# Designing for Inclusion:

The accessibility challenges of some active travel infrastructure for people with vision impairment and other disabled people.

Summary document  
and Guide Dogs' recommendations

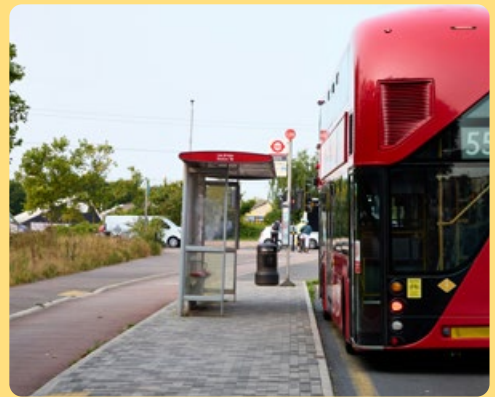
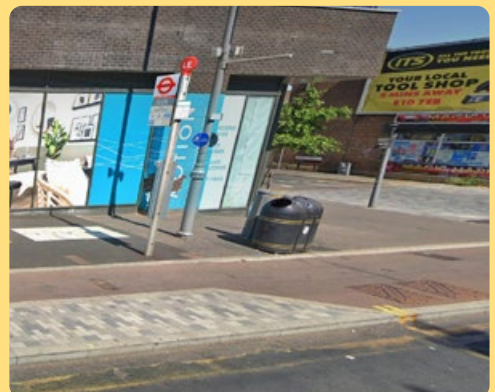
- Floating Island Bus Stops, where the cycle path diverts from the kerbside to behind the bus stop, so buses are free to stop next to the bus stop.
- Shared Bus Stop Boarders, where the cycle path continues next to the kerb. This means the bus has to stop next to the cycle path, rather than the bus stop.

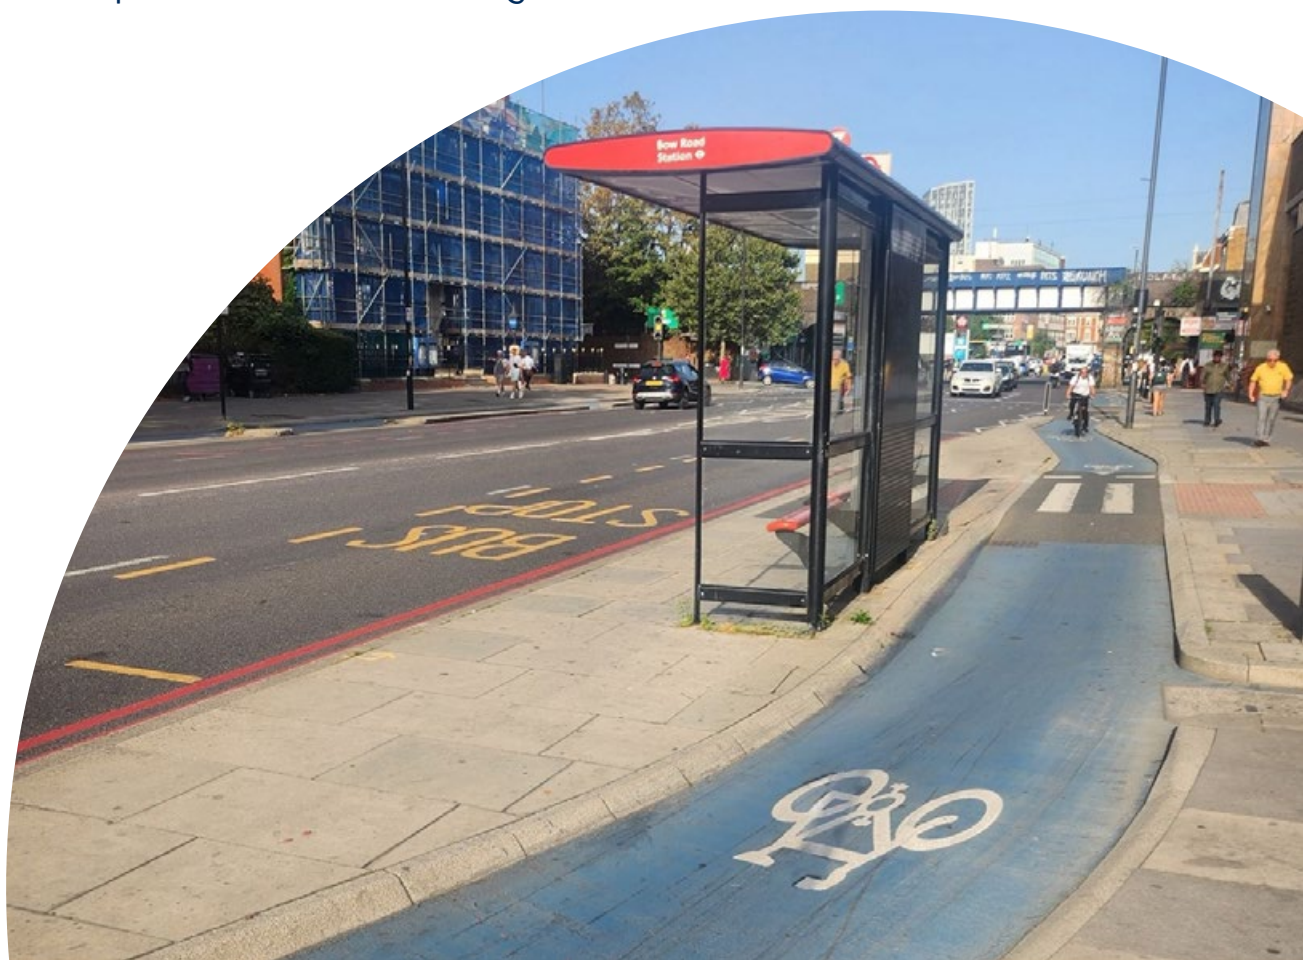
In these cases, anyone wishing to use the bus needs to cross the cycle path. To do so, there is usually a raised mini-zebra type crossing in the cycle path to ensure level access to the bus stop from the pavement. Tactile paving is installed on either side of the cycle path to alert people with visual impairments of the crossing.

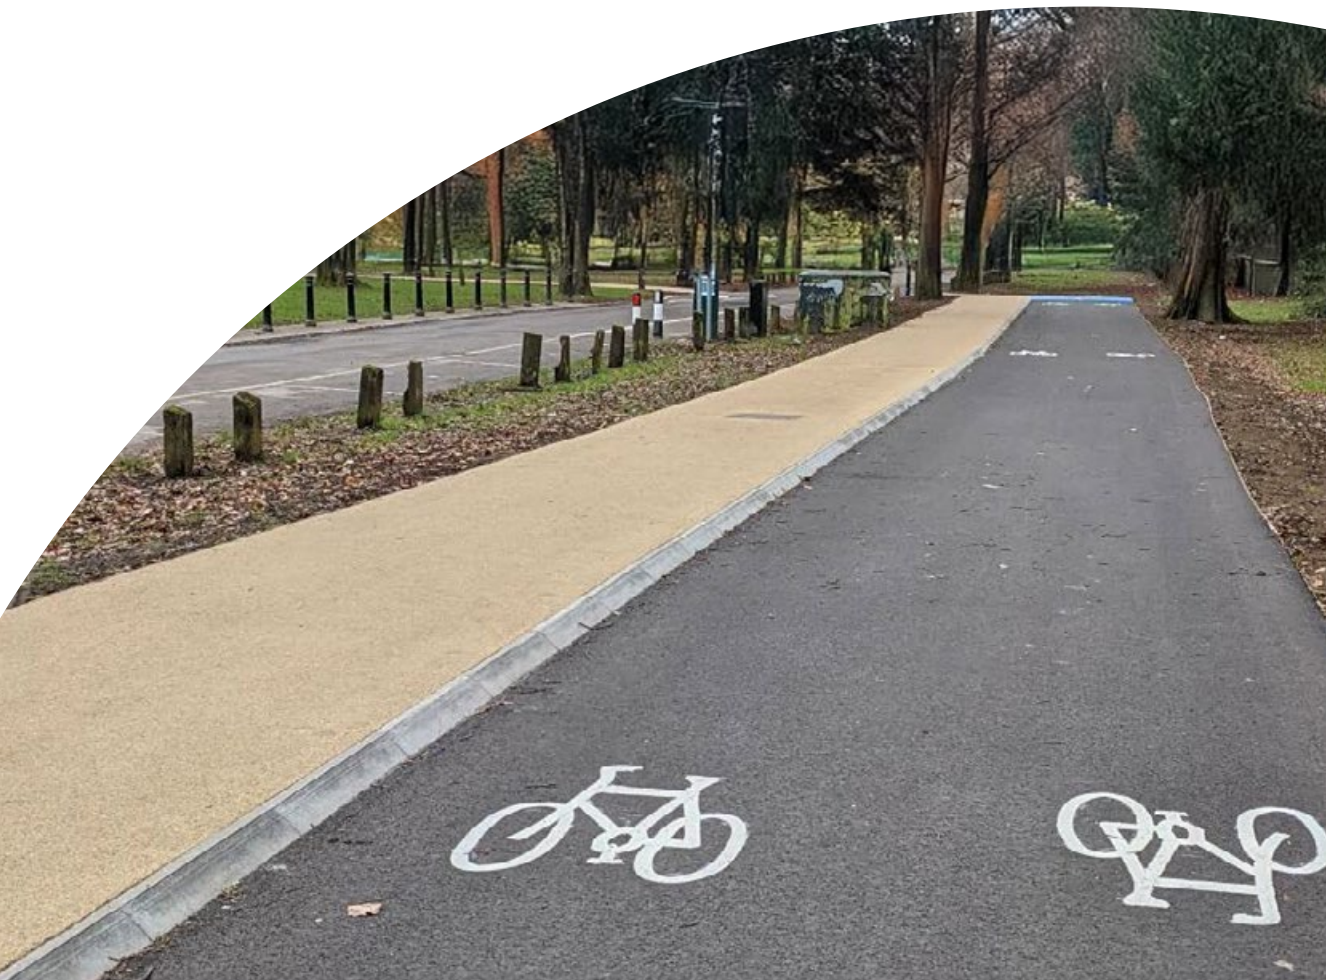
Continuous Footways are where the road is raised to the level of the footway to allow level crossing across a minor road.

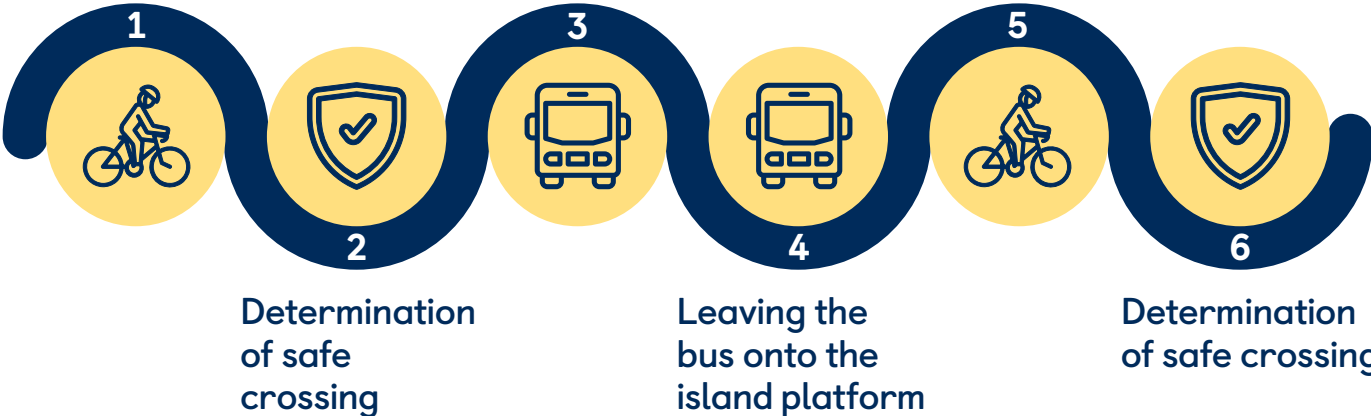
Boarding the bus from the island platform

Detection of cyclists when crossing from the island to the footway

Determination of safe crossing

Leaving the bus onto the island platform

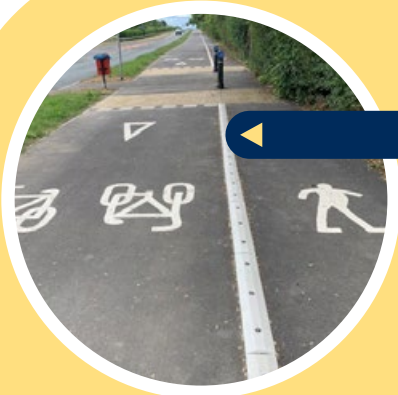
1

A raised trapezoidal continuous delineator, 50mm height, white colour.

These results found that raised trapezoidal continuous delineators were detected by most users, whereas the raised trapezoidal delineator with gaps was less easily detectable. The kerb upstand was even less easy to detect, and the painted white line came last as the least detectable.

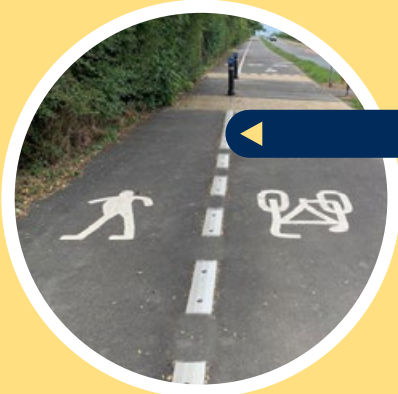
2

A raised trapezoidal delineator with gaps, 50mm height, white colour.

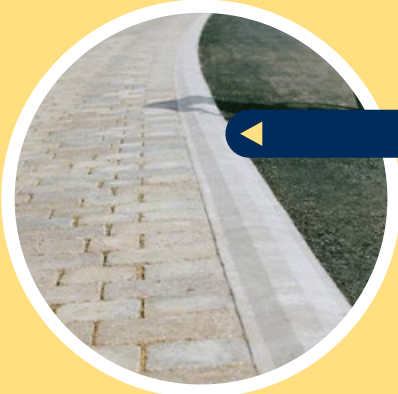
3

A kerb upstand with the edge of the kerb painted white.

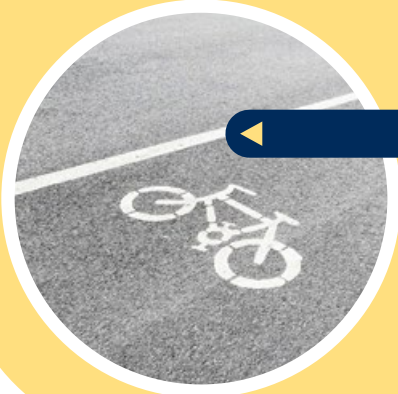
4

A continuous painted white line.
